Pipeline failure in the Mediterranean Sea

Mark Sim, T.D. Williamson, Inc., explains how engineering, isolation and innovative technology helped to restore a severed high-pressure subsea gas pipeline.

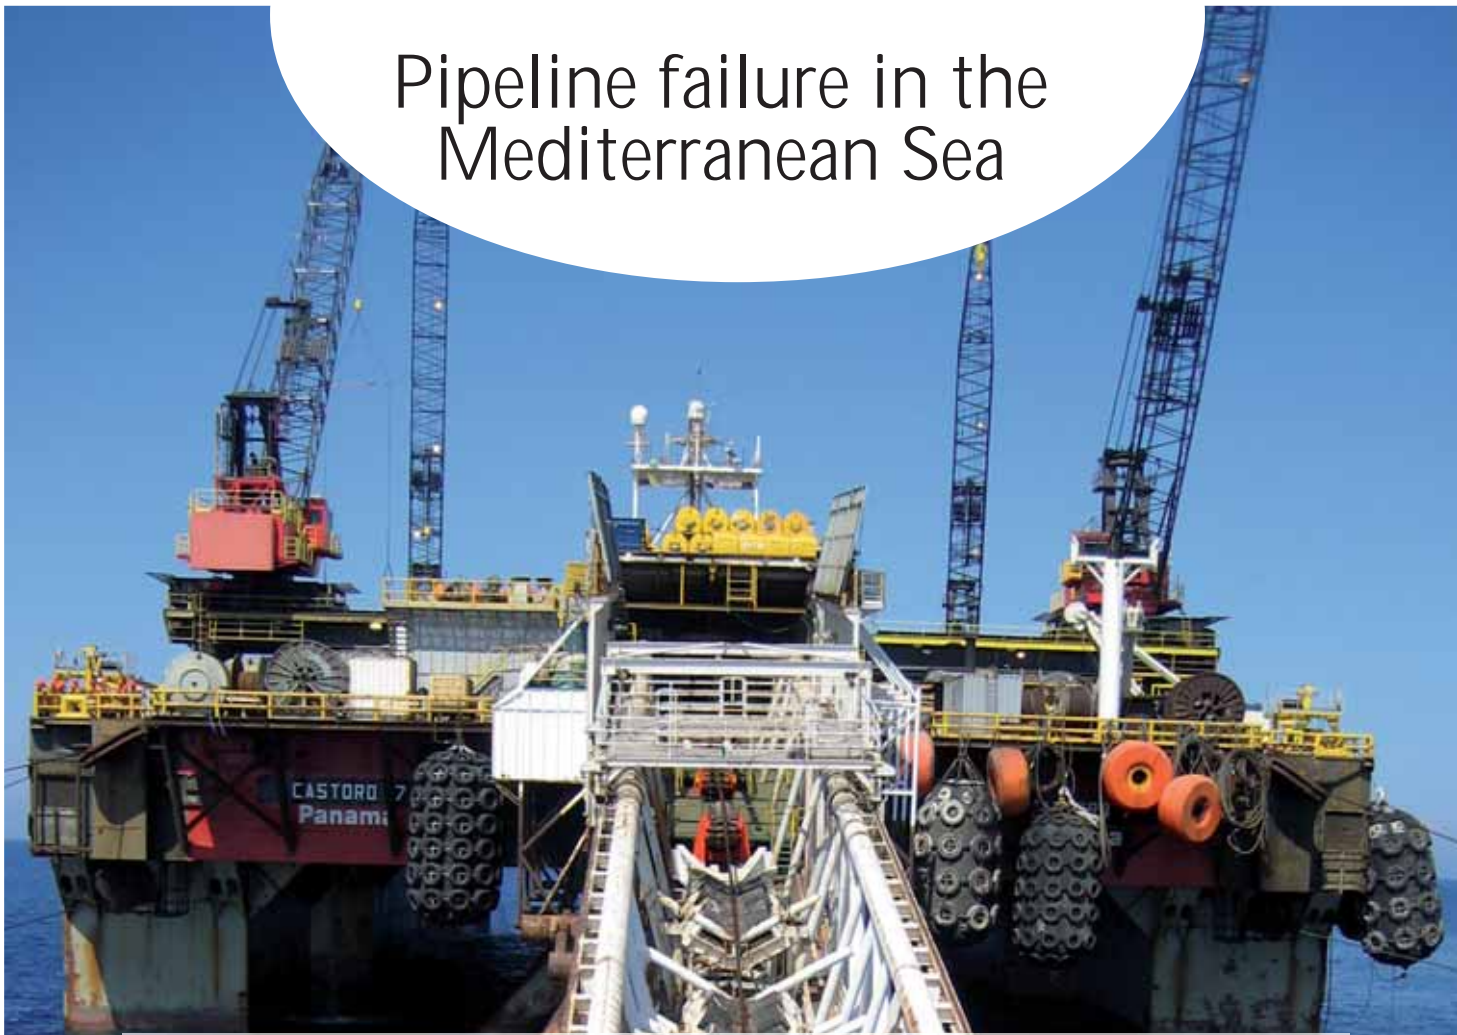
Figure 1. The line has been dewatered and the winch is connected to the PRT, pulling the pipeline onto the vessel.

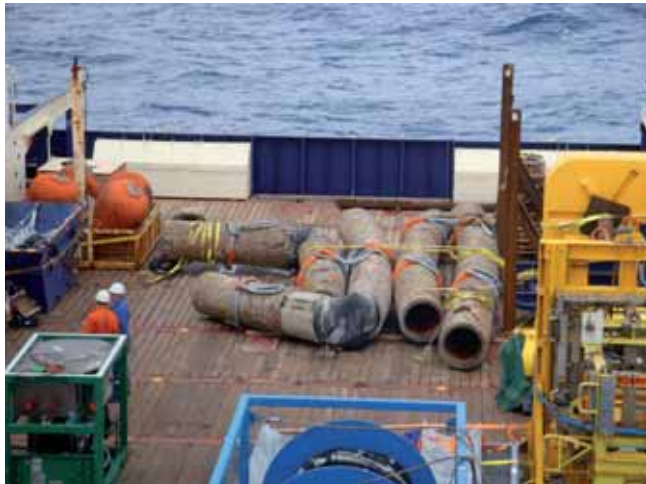
Figure 2. When a 26 in. pipeline was completely severed by a dragging anchor, it resulted in catastrophic failure of the line. The recovered pipe was severely deformed.

The pipeline repair contractor proceeded to repair the 26 in. line. The pipe ends were recovered, and an above water tie-in performed, prior to laydown. The line was then re-commissioned by drying, filling with nitrogen, and packing with gas before being re-started, allowing production to resume. This was followed by repair of the 20 in. line by the pipeline repair contractor, who employed the same process. The line was re-commissioned by drying, filling with nitrogen, and packing it with gas before it was re-started, allowing production to resume.

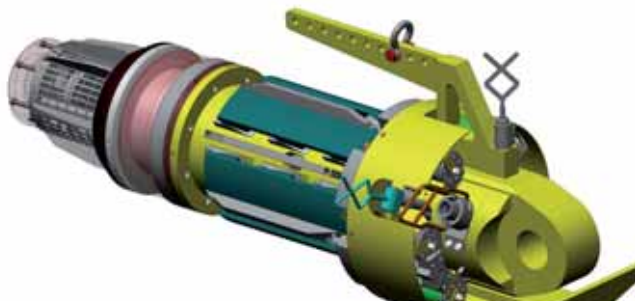
Figure 3. Customised SmartLift™ PRT.

During brainstorming sessions with the pipeline repair contractor, TDW assessed options to decommission and repair the two lines. TDW had previously designed and manufactured a custom SmartLift™ pipeline recovery tool (PRT) for a project carried out subsea in much deeper water (Figure 3). By using the SmartLift™ PRT, it would be possible to recover and dewater the recovered pipe. The PRT's internal gripping function is hydraulically activated by a remotely operated vehicle (ROV) or diver, and self-locks mechanically after it is set. At the same time, packers are activated, providing a seal. Dewatering is carried out by running a dewatering pig either from a launcher or to a receiver attached to the PRT. During the early planning stages, it was agreed that PRTs would be used, with delivery and design the primary issues.

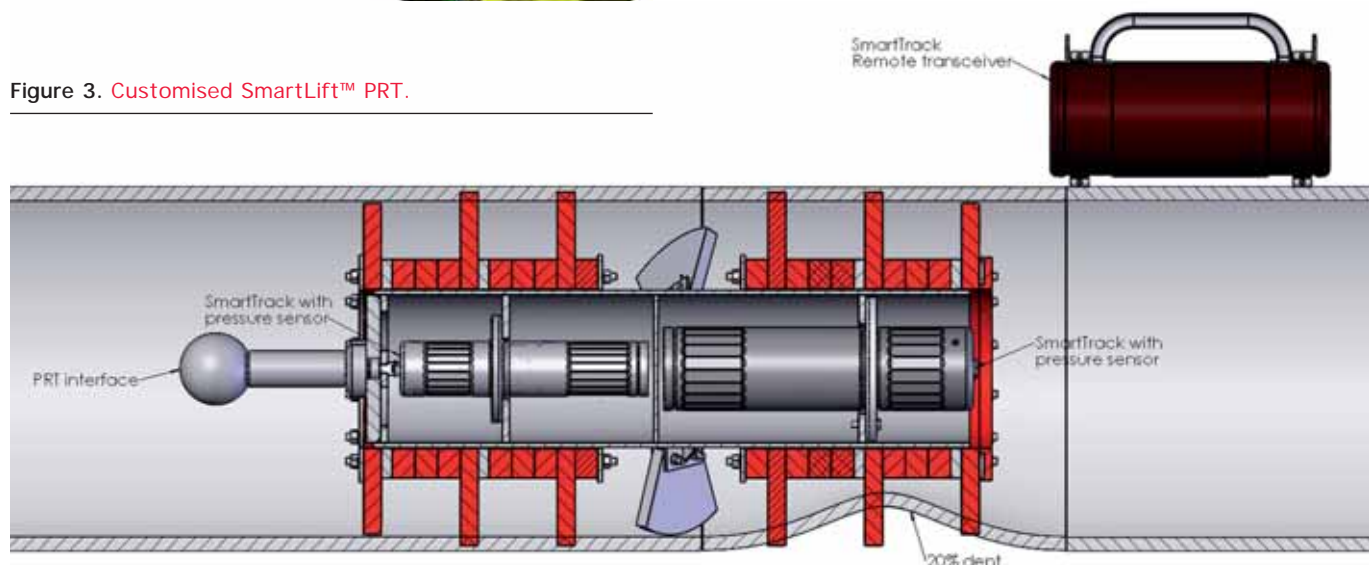
Figure 4. Custom pig set-up.

At its facility in Stavanger, Norway, TDW designed and built a test rig with a built-in dent in excess of the 14% actual deformation (Figure 4). In essence, a 16 – 20 in. dual diameter pig was required. A range of configurations were tested to simulate the conditions subsea. Flip pressures, launch pressures, holding pressures, and pigging pressure across the dent were measured and optimised during the test to ensure optimal performance offshore.

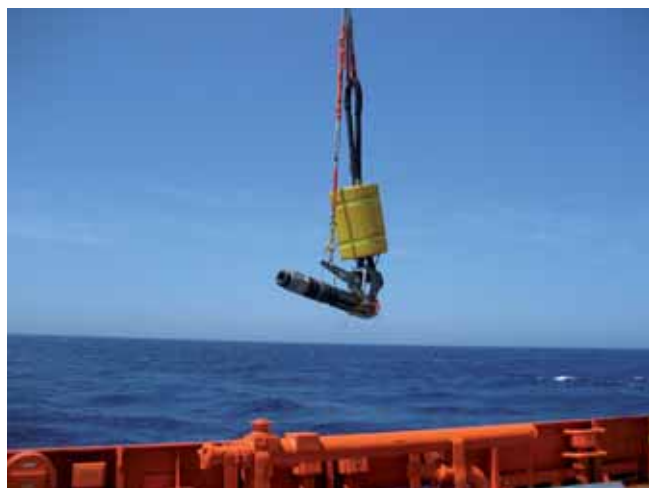
Figure 5. The custom SmartLift™ PRT is deployed from the lay vessel.

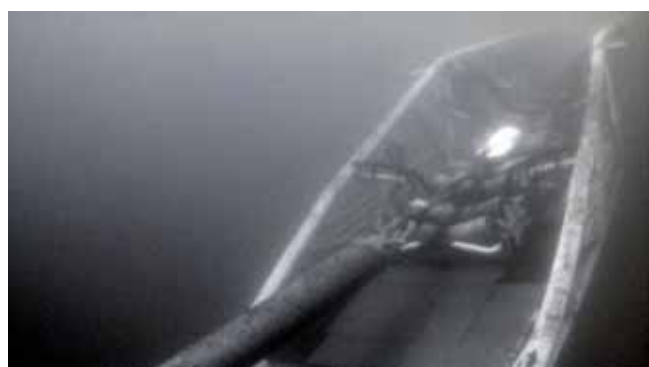
Figure 6. The PRT recovers the pipe by drawing it up the stinger.
