EARTH, WIND—AND FIRE: PIPELINE ISOLATION

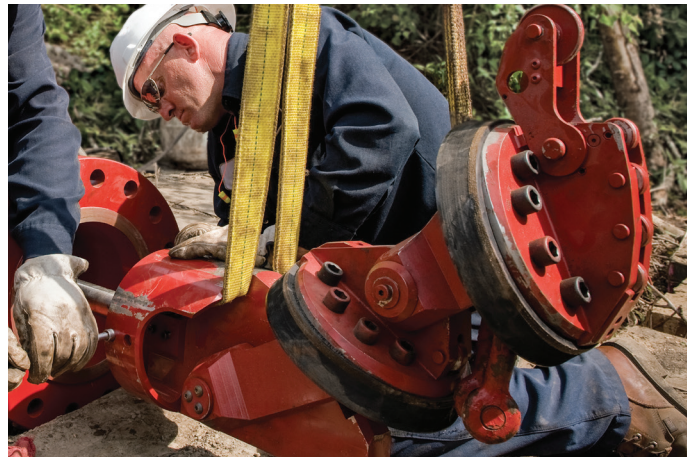
With the STOPPLE® Train’s double block and bleed (DBB) technology, two independent plugging heads were inserted into the line through a single fitting, eliminating the need for multiple taps.

Once the system was set, the area between the heads was bled through a bleed port. To ensure no leaks occurred, the port was left open and monitored so that if any product seeped past the primary seal, it could be removed from the line and safely captured or evacuated to a safe location. The STOPPLE® train created a zone of “zero energy,” ensuring no product escaped past the STOPPLE® barrier.

FIGURE 1 STOPPLE TRAIN ISOLATION TECHNOLOGY
